# High Test Peroxide Incident at Stennis Space Center

R. Ross, D. Sewell, M. Cockrell

Propulsion Test Directorate, Building 4010  
NASA John C. Stennis Space Center, MS 39529  
Telephone: (228)688-2320, Fax (228)688-1485, Robert.Ross@ssc.nasa.gov

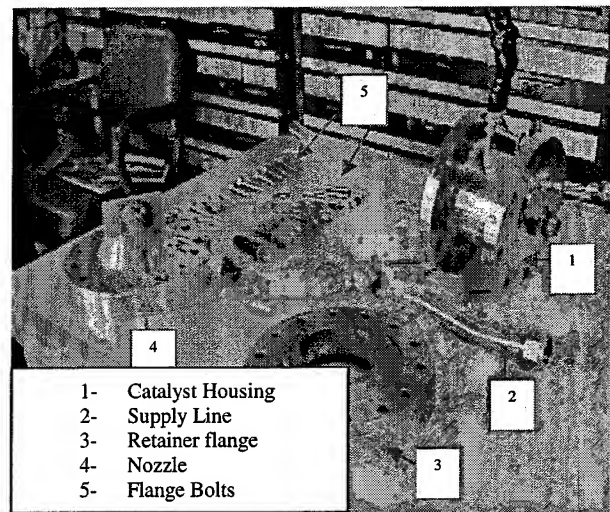
Figure 1: Test Hardware Overview

The event occurred approximately one second into the test following the completion of a successful test. Damage to the facility included rupturing a one inch diameter stainless steel supply line rated for 29 MPa (4200 PSI) and the destruction of a pre-valve rated for 20.7 MPa (3000 PSI) service. For the test article, fourteen 1.27 CM (0.5 inch) diameter stainless steel bolts failed in tension and a portion of the test article (~ 7.3 Kg or 16 Lbm) was ejected thirty meters from the test stand. Figures 1-4 show post test photographs of selected hardware.

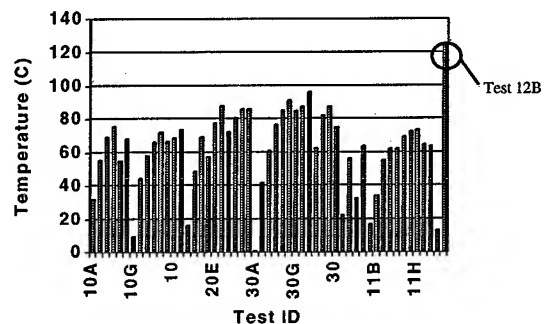
Figure 6: Test Article Initial Temperature

Figure 6 shows the initial temperature of the hardware for all of the tests in the series. At 121°C (250°F) the initial temperature for the final test was approximately 28 °C (50 °F) higher than previous tests. Figure 7 shows the transient response of the test article three minutes prior to the start of test. As shown in the figure, the test article is heated by the decomposing peroxide as it leaks from the valve and comes in contact with the catalyst. Additionally, peroxide vapor is created as a product of the liquid in contact with the hot test hardware.

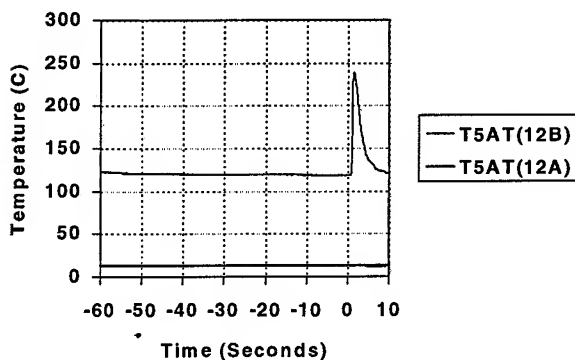
Figure 8: Thermal Response Data

Figure 8 shows the thermal response of the temperature sensor in the test article over a period of 70 seconds including one minute prior to the start of the test. The temperature sensor is located to measure the fluid temperature of the peroxide in the test article and the nominal test response is shown in test 12A. As shown in the figure, for test 12A the test article and fluid temperature were at ambient temperature prior to the start of the test. In contrast, the temperature at the start of test 12B increases over 110 °C (200°F) over a period of approximately one second. Heat is a byproduct of the peroxide decomposition reaction and the data show that there was a large amount of heat generated in a very short period of time.

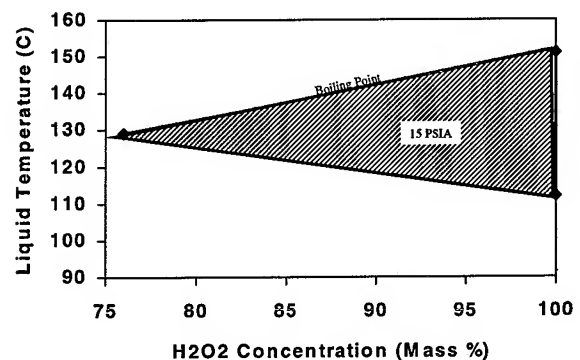
Figure 9: Critical Temperatures for Peroxide at Ambient Pressure

Critical vapor concentrations are well defined as a function of concentration and pressure [2]. Figure 9 shows the critical temperature range for generating potentially dangerous levels of peroxide vapor at ambient pressure. As shown in the figure, the critical temperature range increases as the concentration increases, thus, 98% concentration is more sensitive to temperature than 85%. For the case at hand, it is known that peroxide vapor/liquid was present and that the temperature was approximately 121°C (250°F) at the start of the final test. These conditions are sufficient to create a dangerous vapor concentration at the start of the test. In addition, Figure 10 shows the critical vapor concentration as a function of pressure. As shown in the figure, the relationship is logarithmic with respect to pressure and concentration and the critical concentration decreases as the pressure increases. A high but less than critical vapor concentration in the system at low pressure can translate into a dangerous level by increasing the pressure from ambient to normal operating pressures of 3.4 MPa (500 PSIA).
